THE GREAT ALASKA EARTHQUAKE

Volume II

Illustrations and Maps

TECHNICAL REPORT NO. AFWL-TR-65-92, Vol II

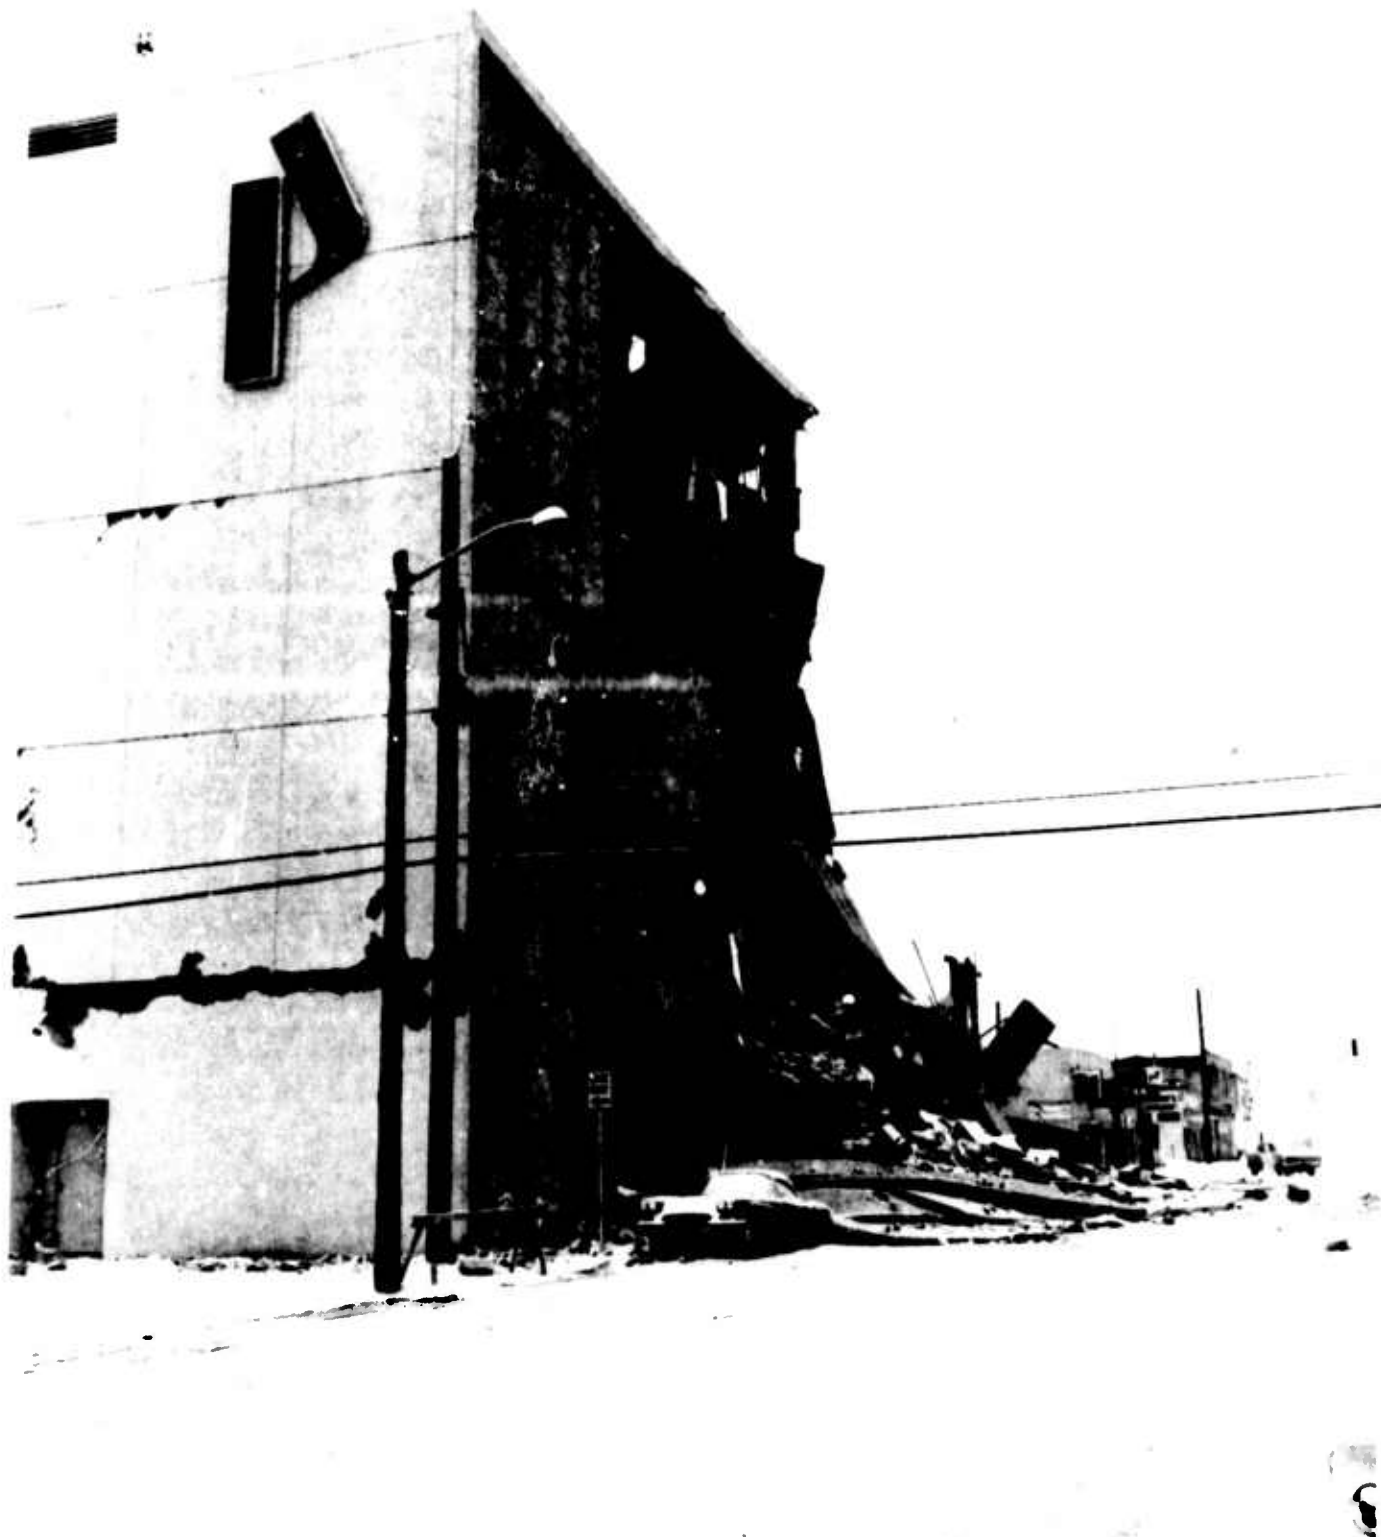
Figure 138. J. C. Penney Building (Unseated shear panels in the east wall. Notice the scalloped bottoms of the shear panels.)

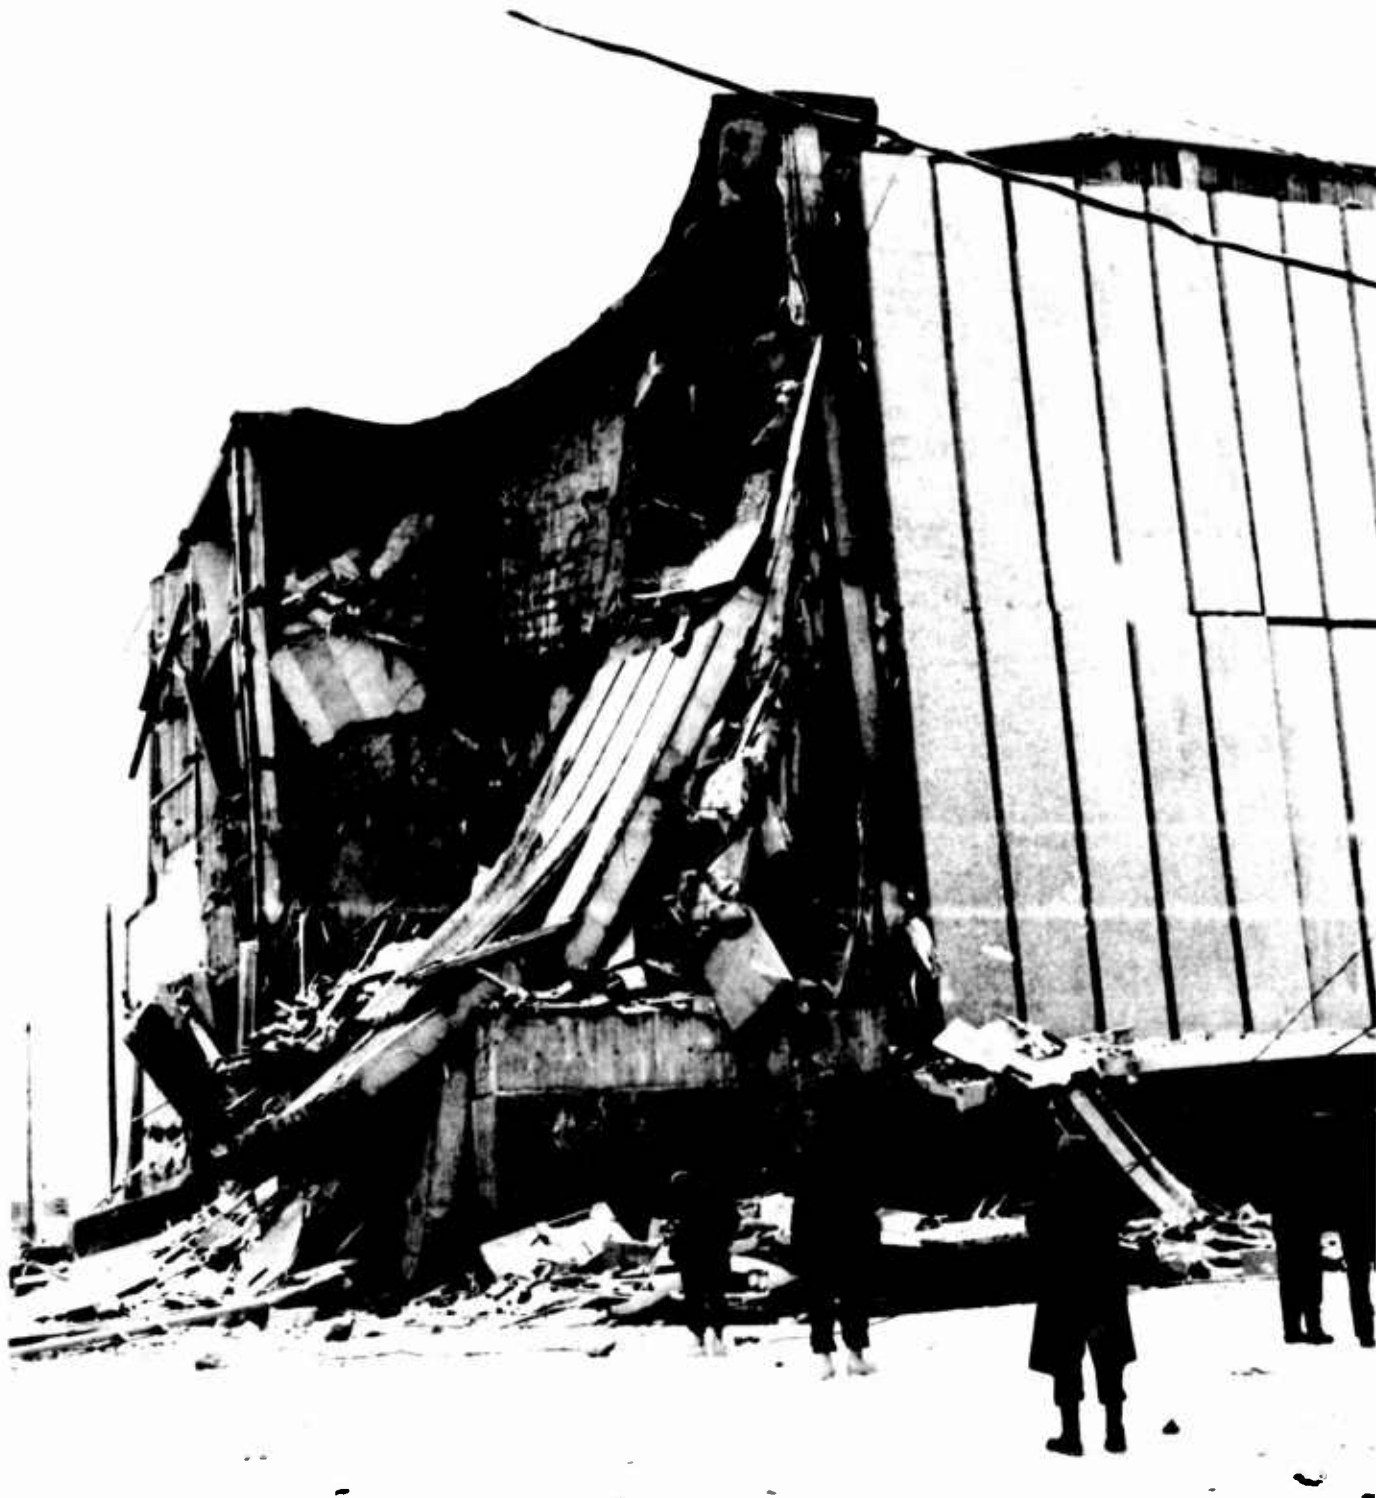
Figure 139. J. C. Penney Building
(Collapsed northeast corner of the structure)

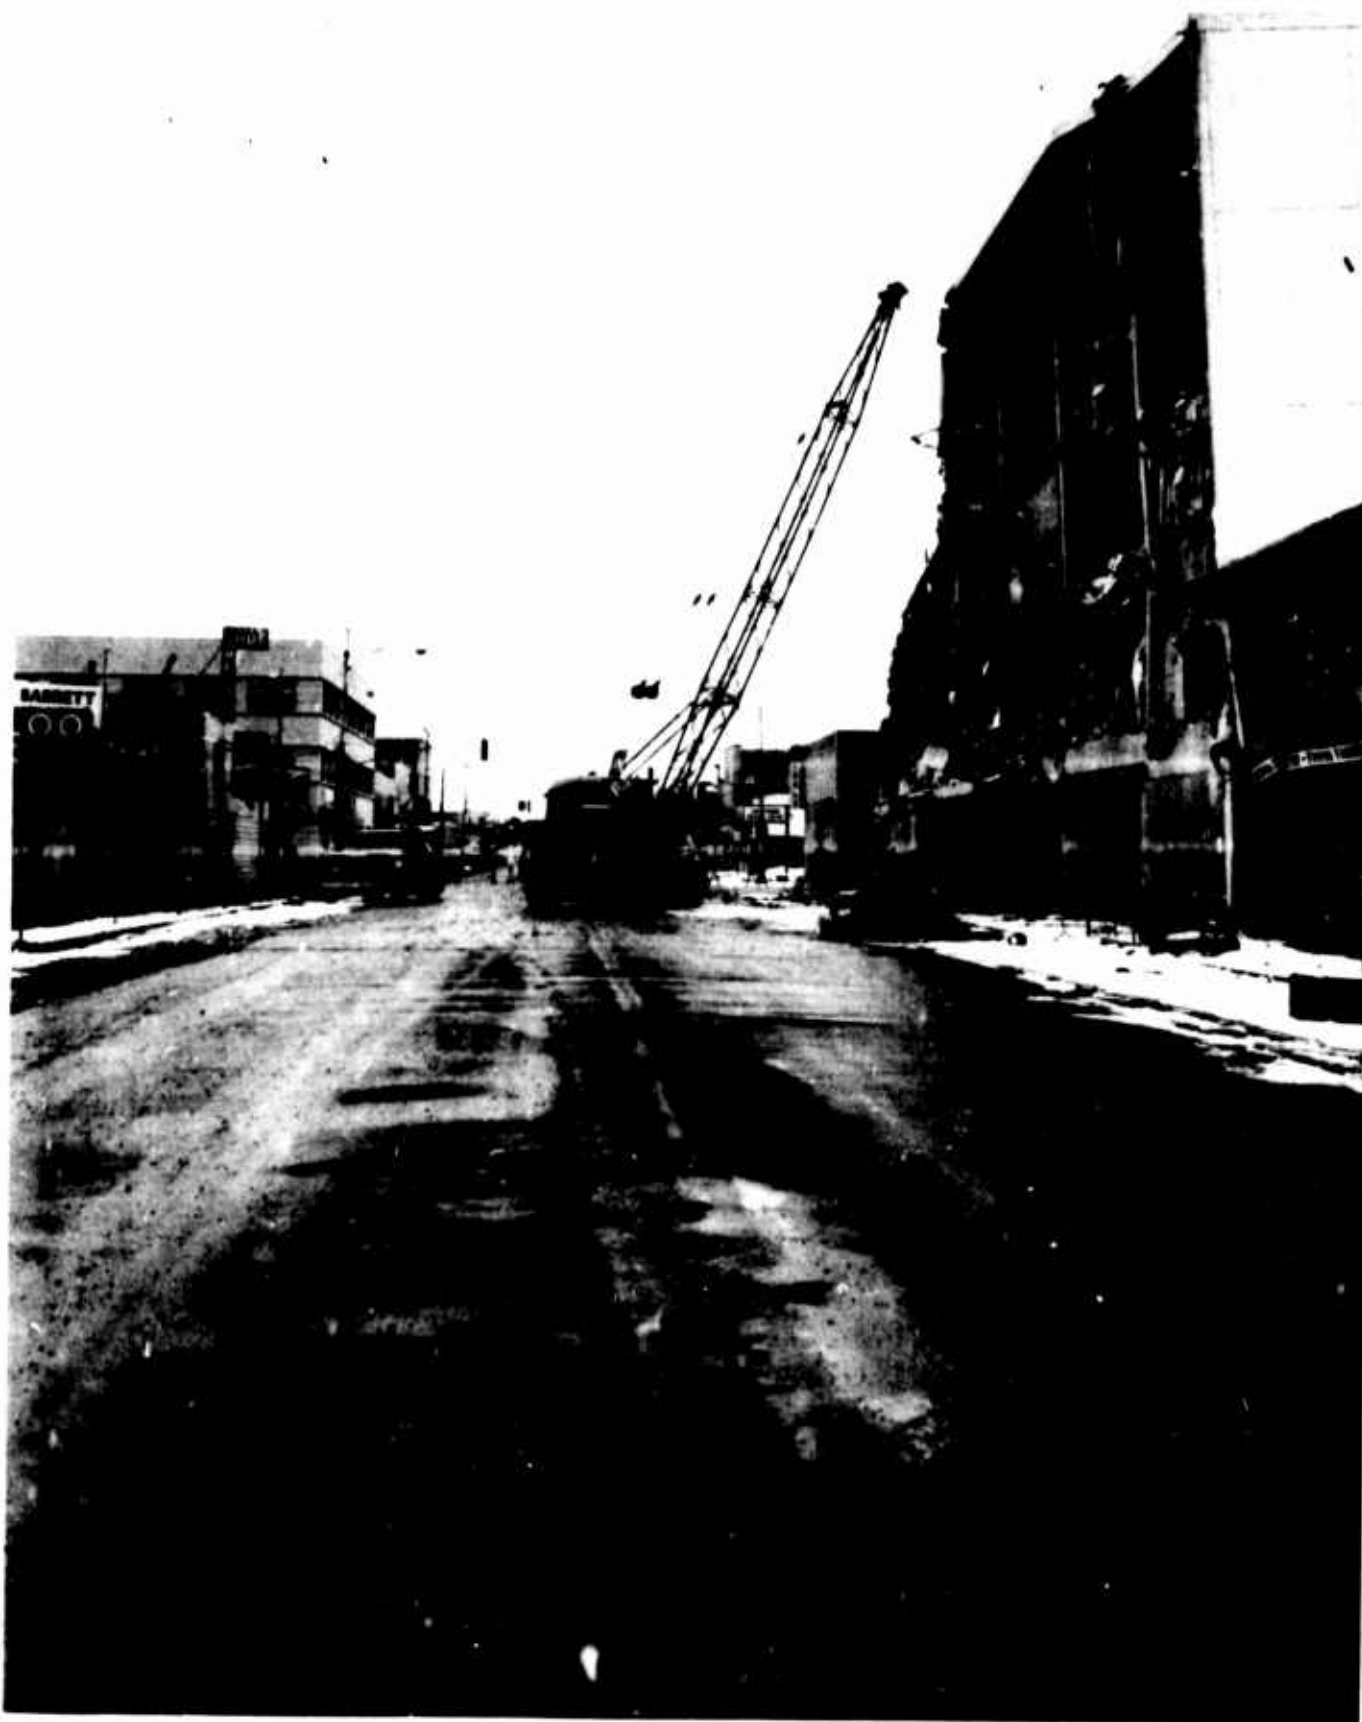
Figure 140. J. C. Penney Building (Damage to the northwest corner of the structure. Notice numerous floor slab failures.)

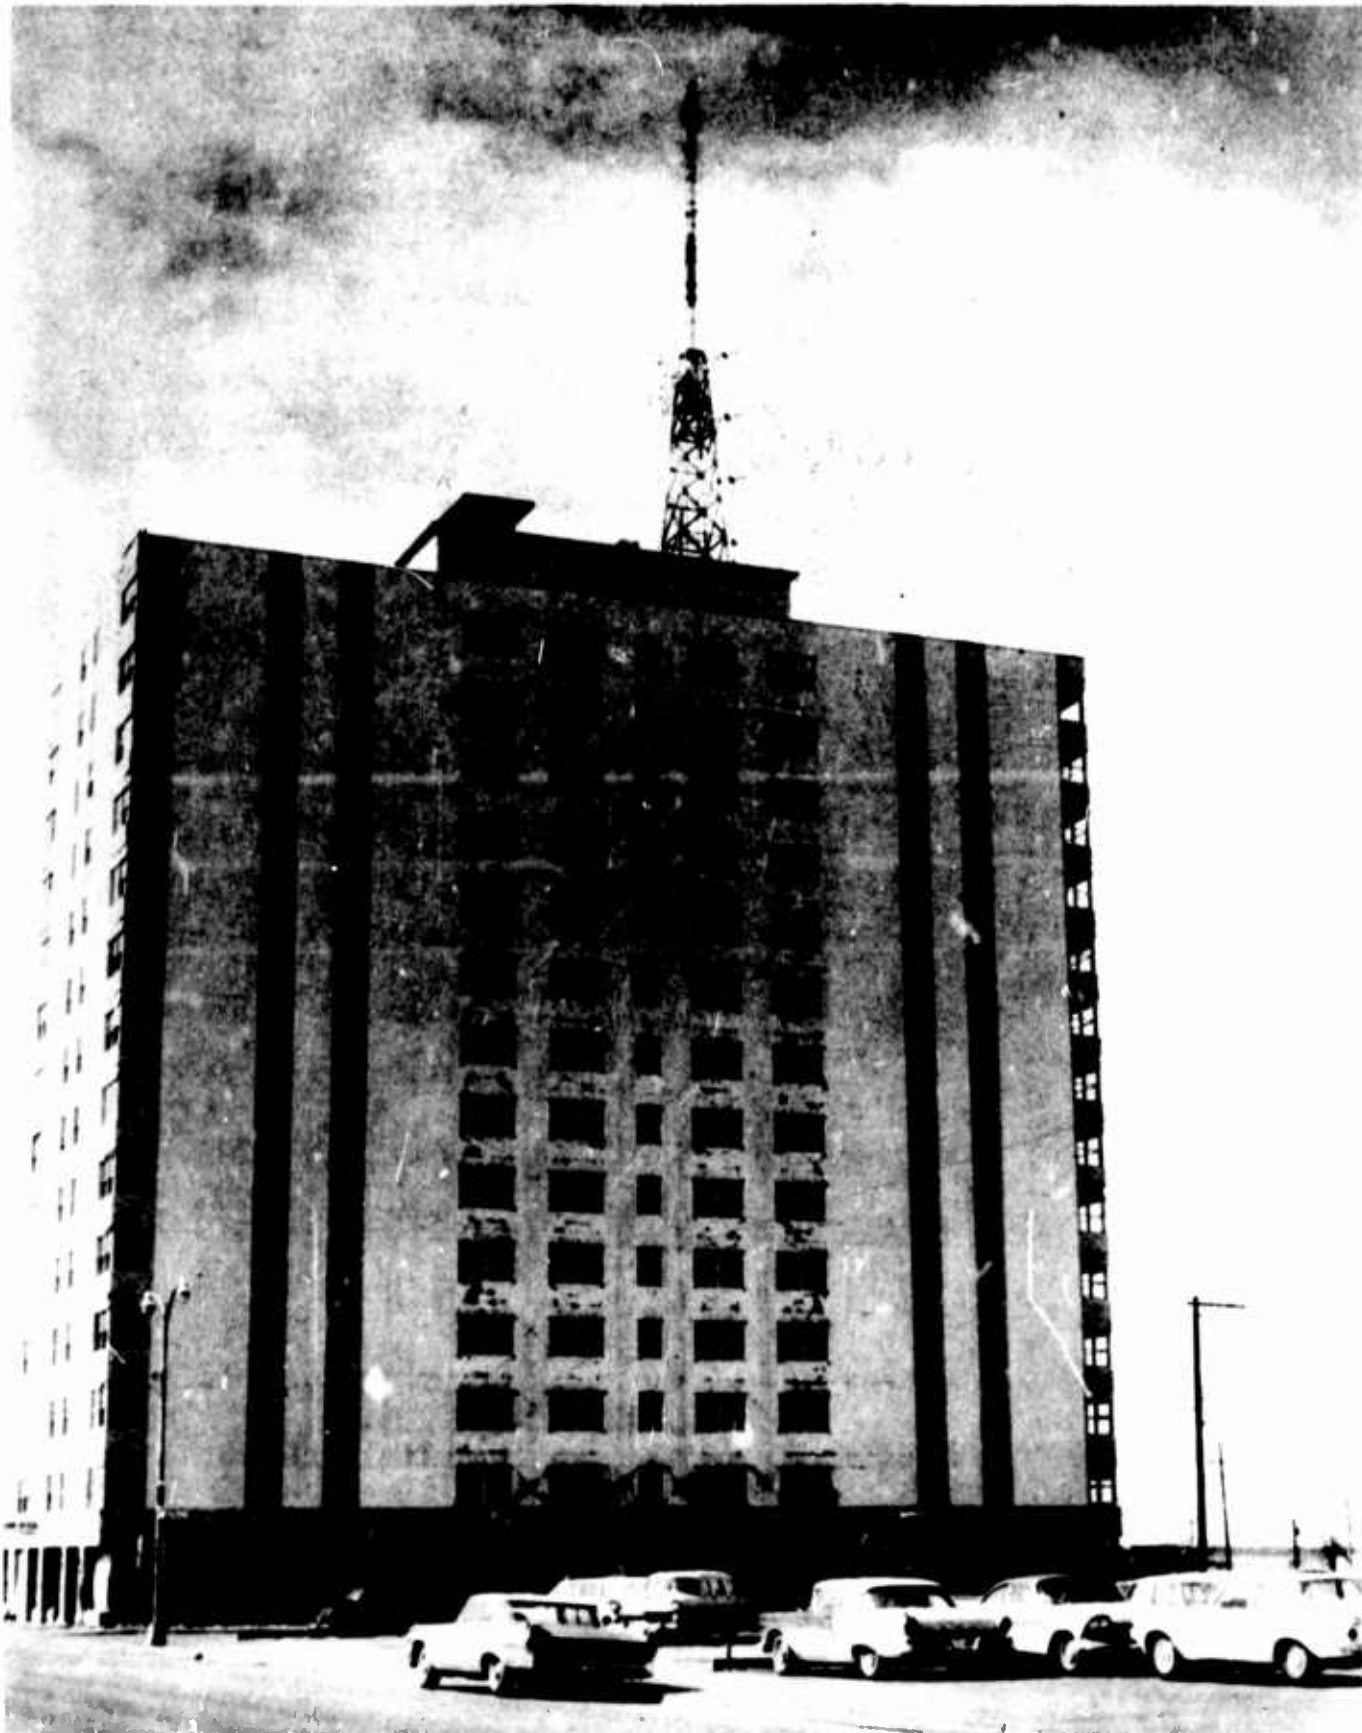
Figure 144. Mount McKinley Building (East side of the fourteen-story reinforced-concrete structure showing diagonal tension cracks in spandrel walls)

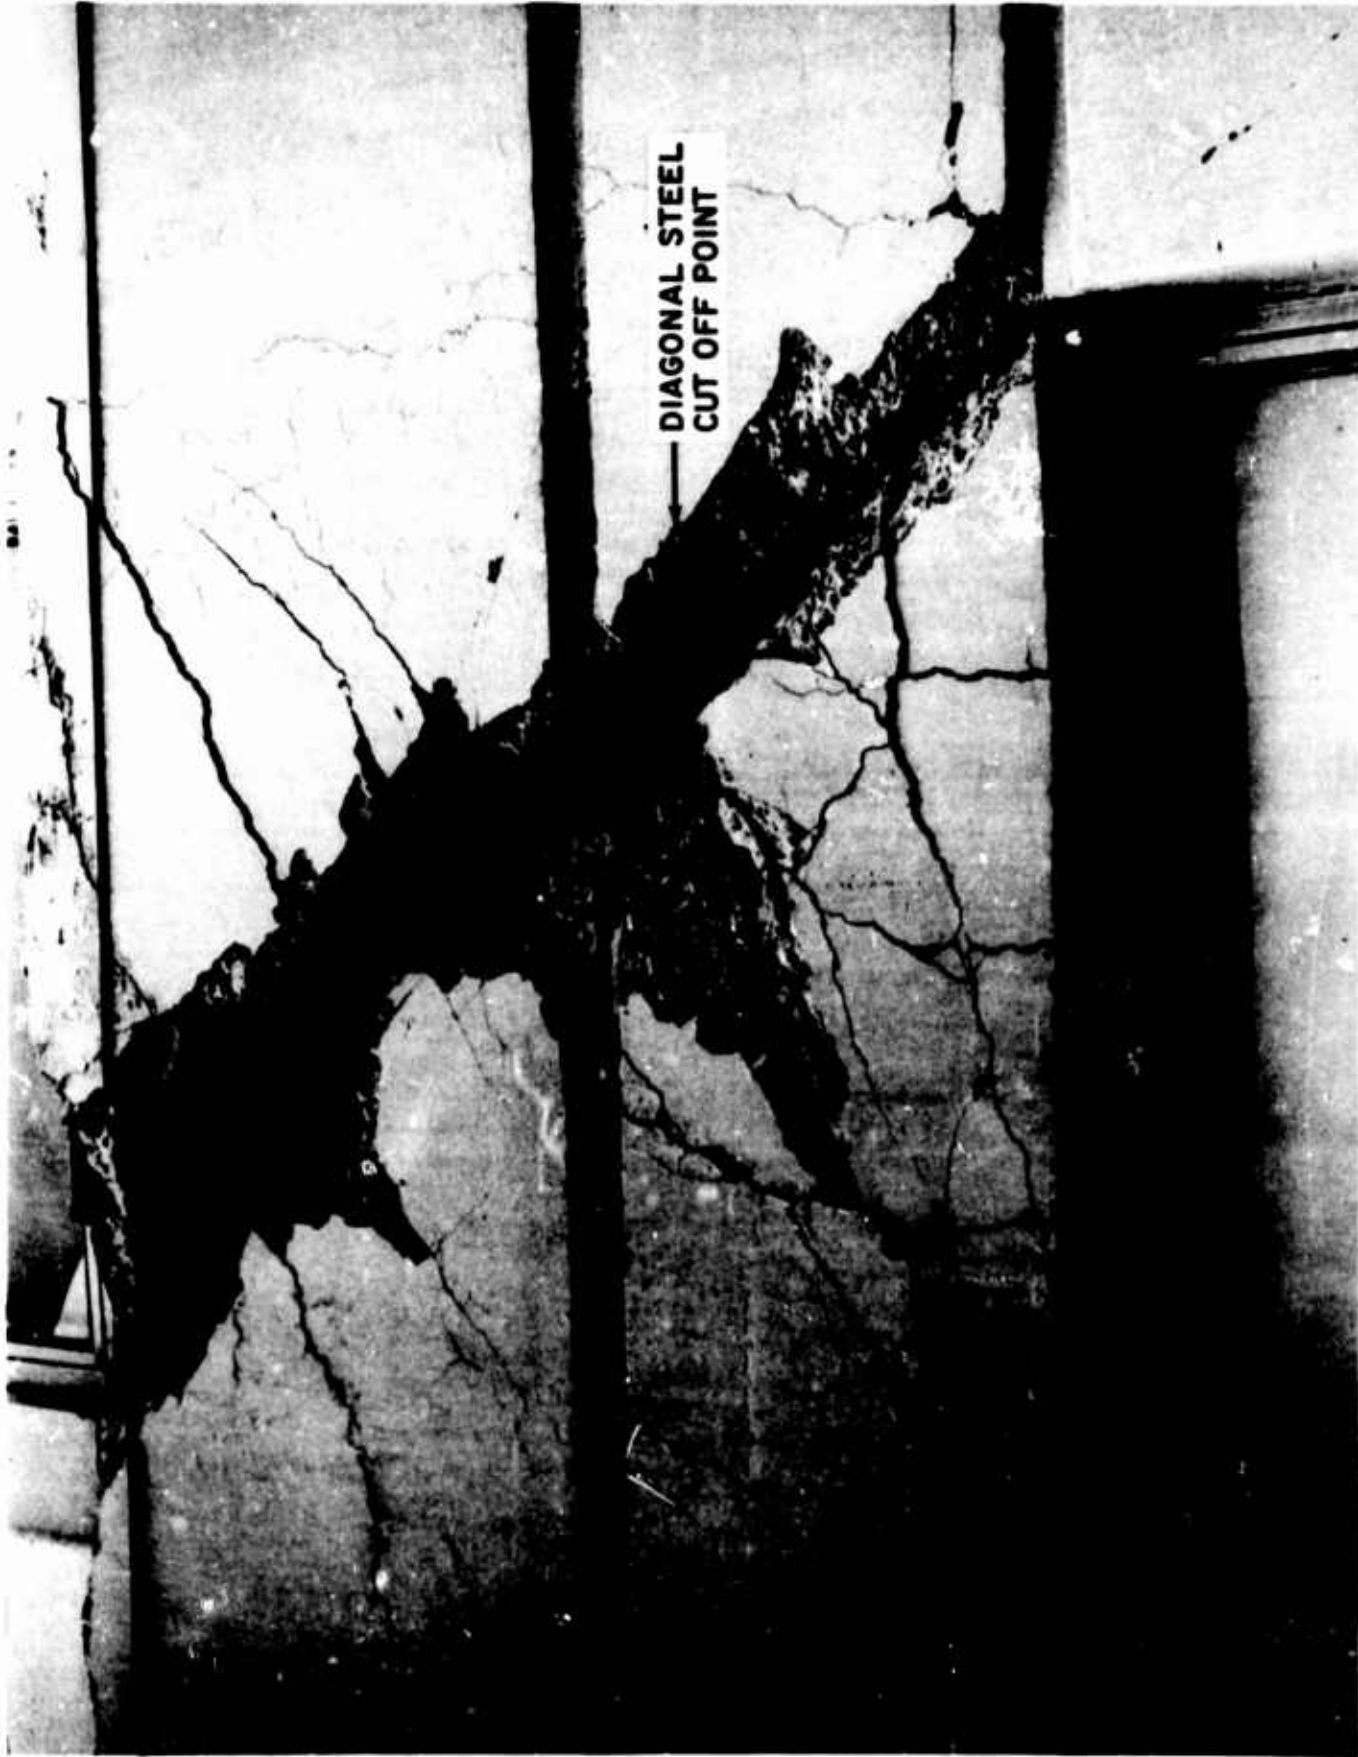
Figure 153. Mount McKinley Building (Diagonal tension failure in east wall at second-floor level)

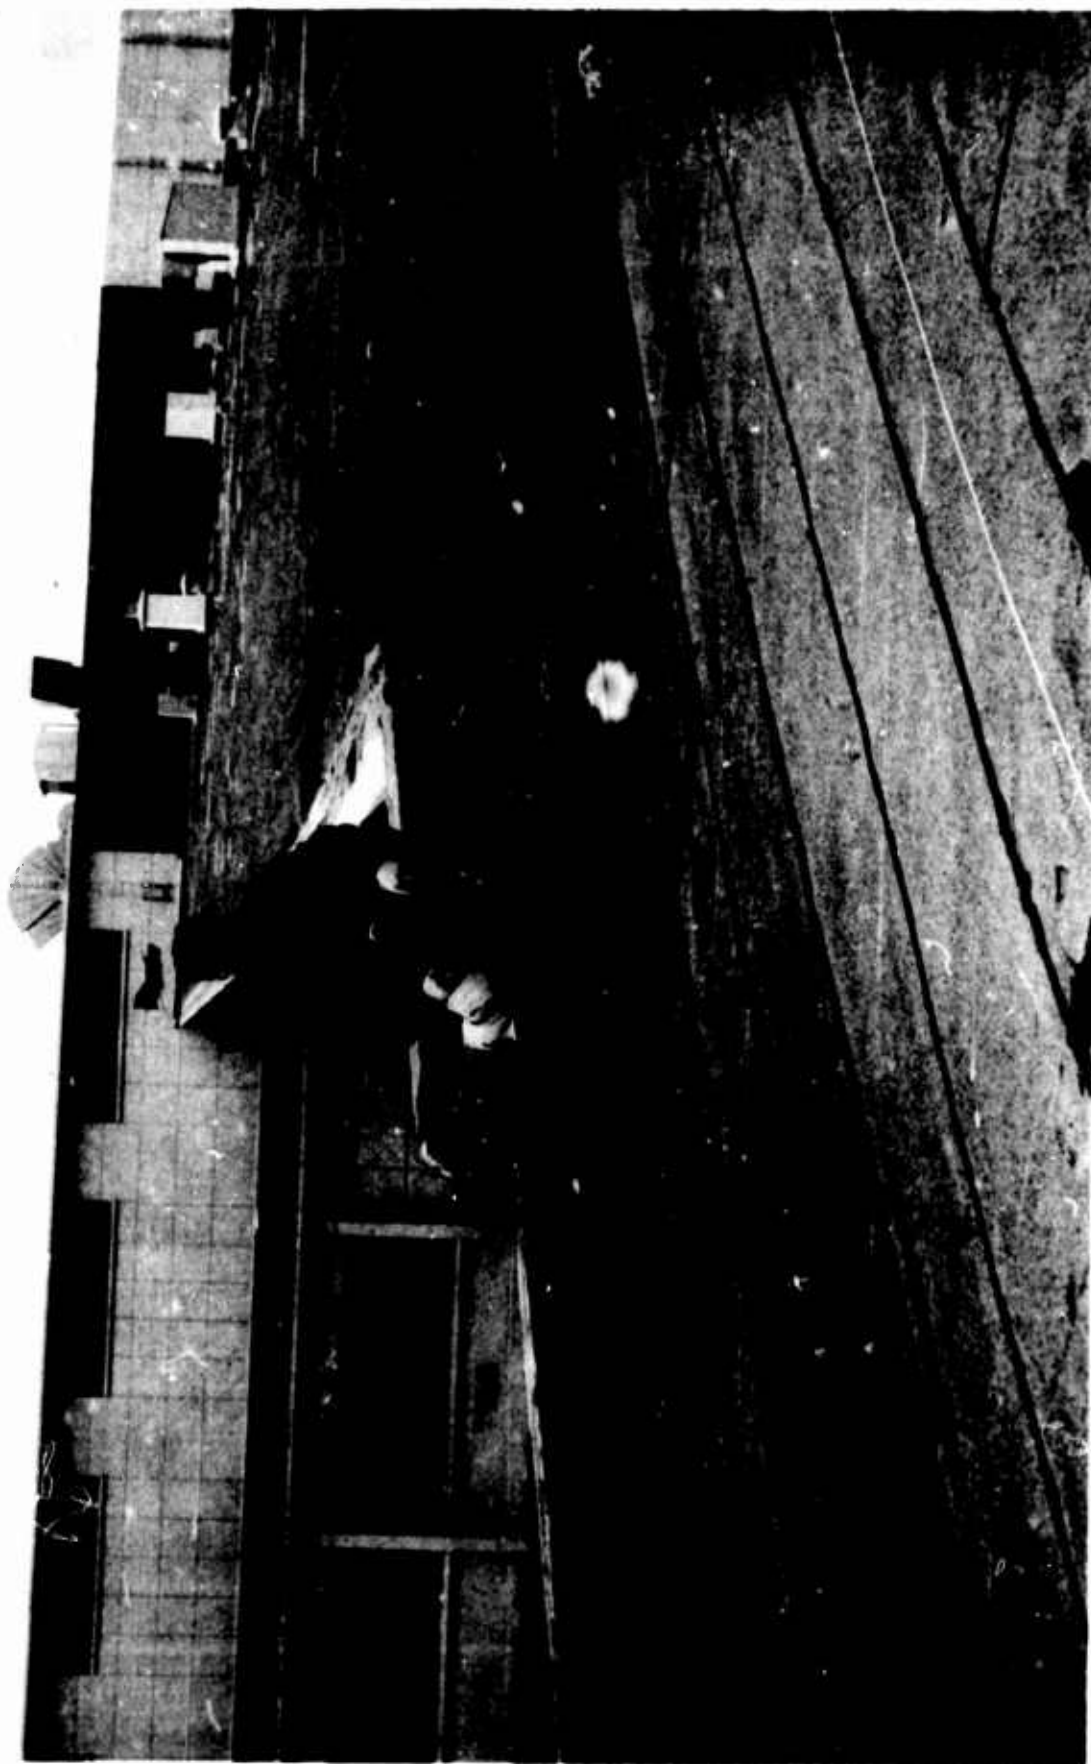
Figure 160. West Anchorage High School (Roof slab fracture near the intersection of wings A and B. Temperature reinforcing normal to the fracture has been sheared.)

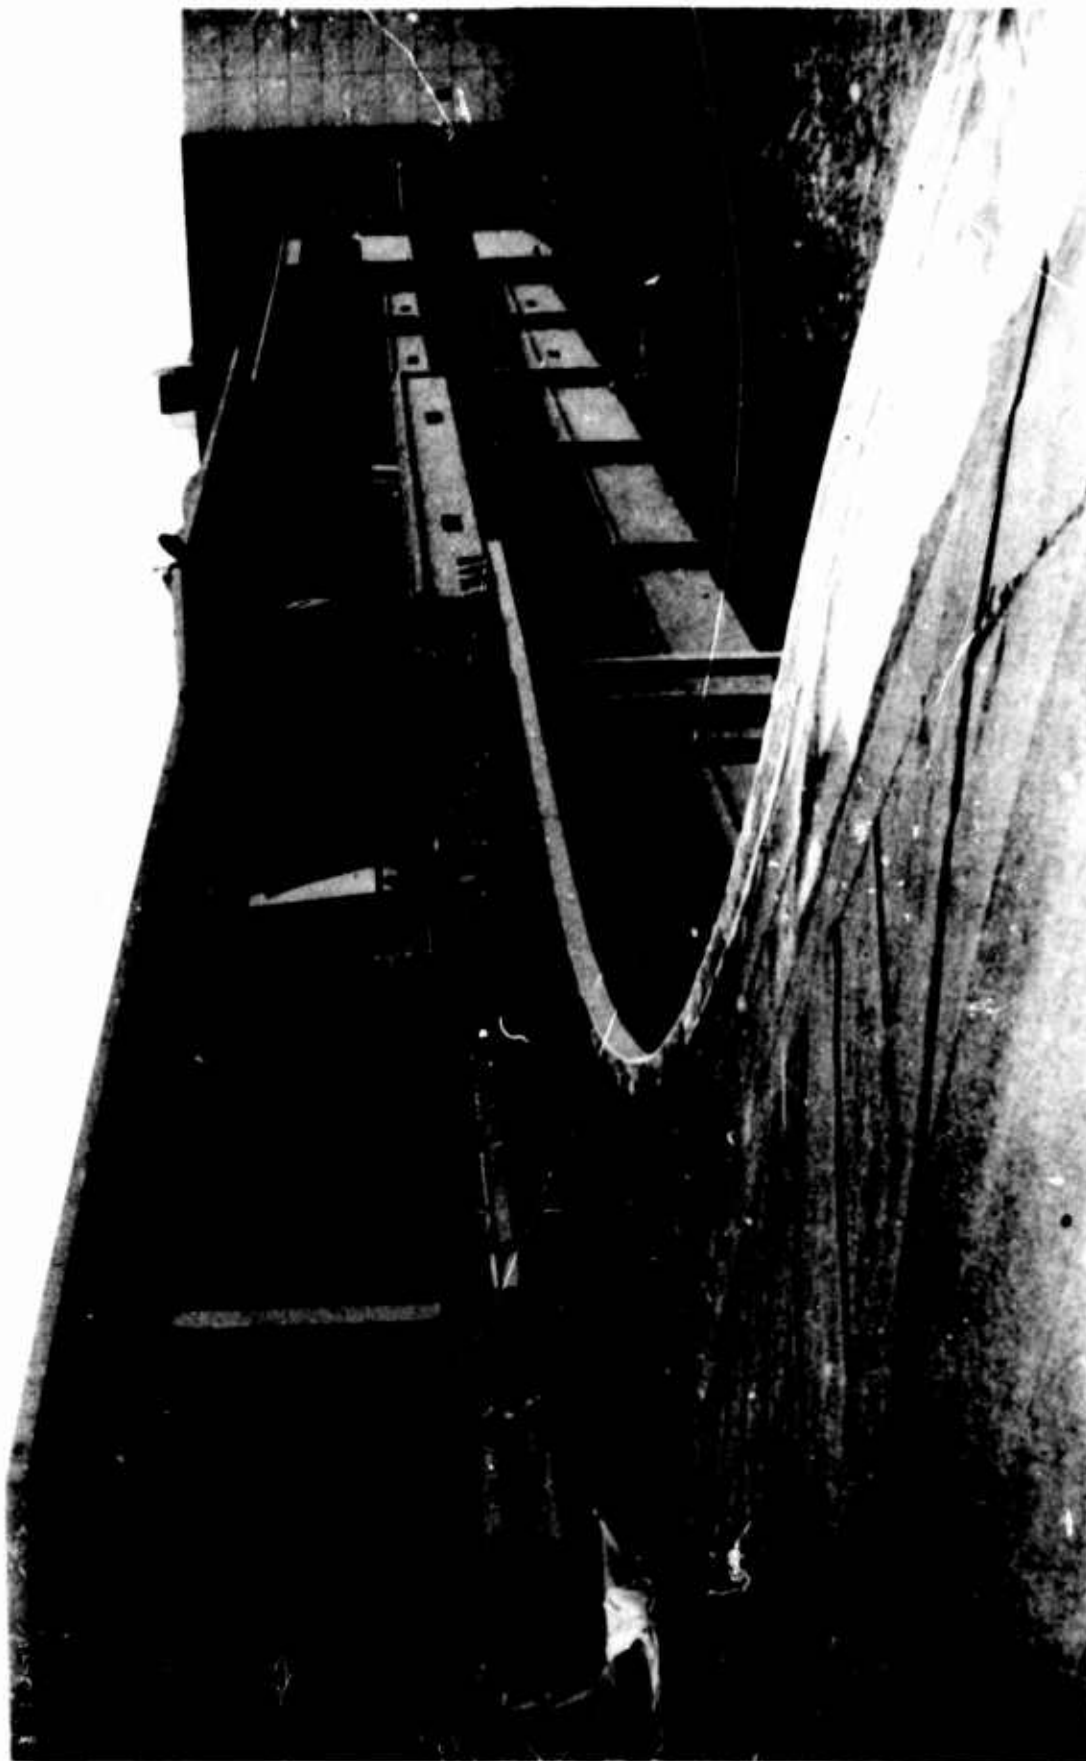
Figure 161. West Anchorage High School (Damage at intersection of wings A and B)

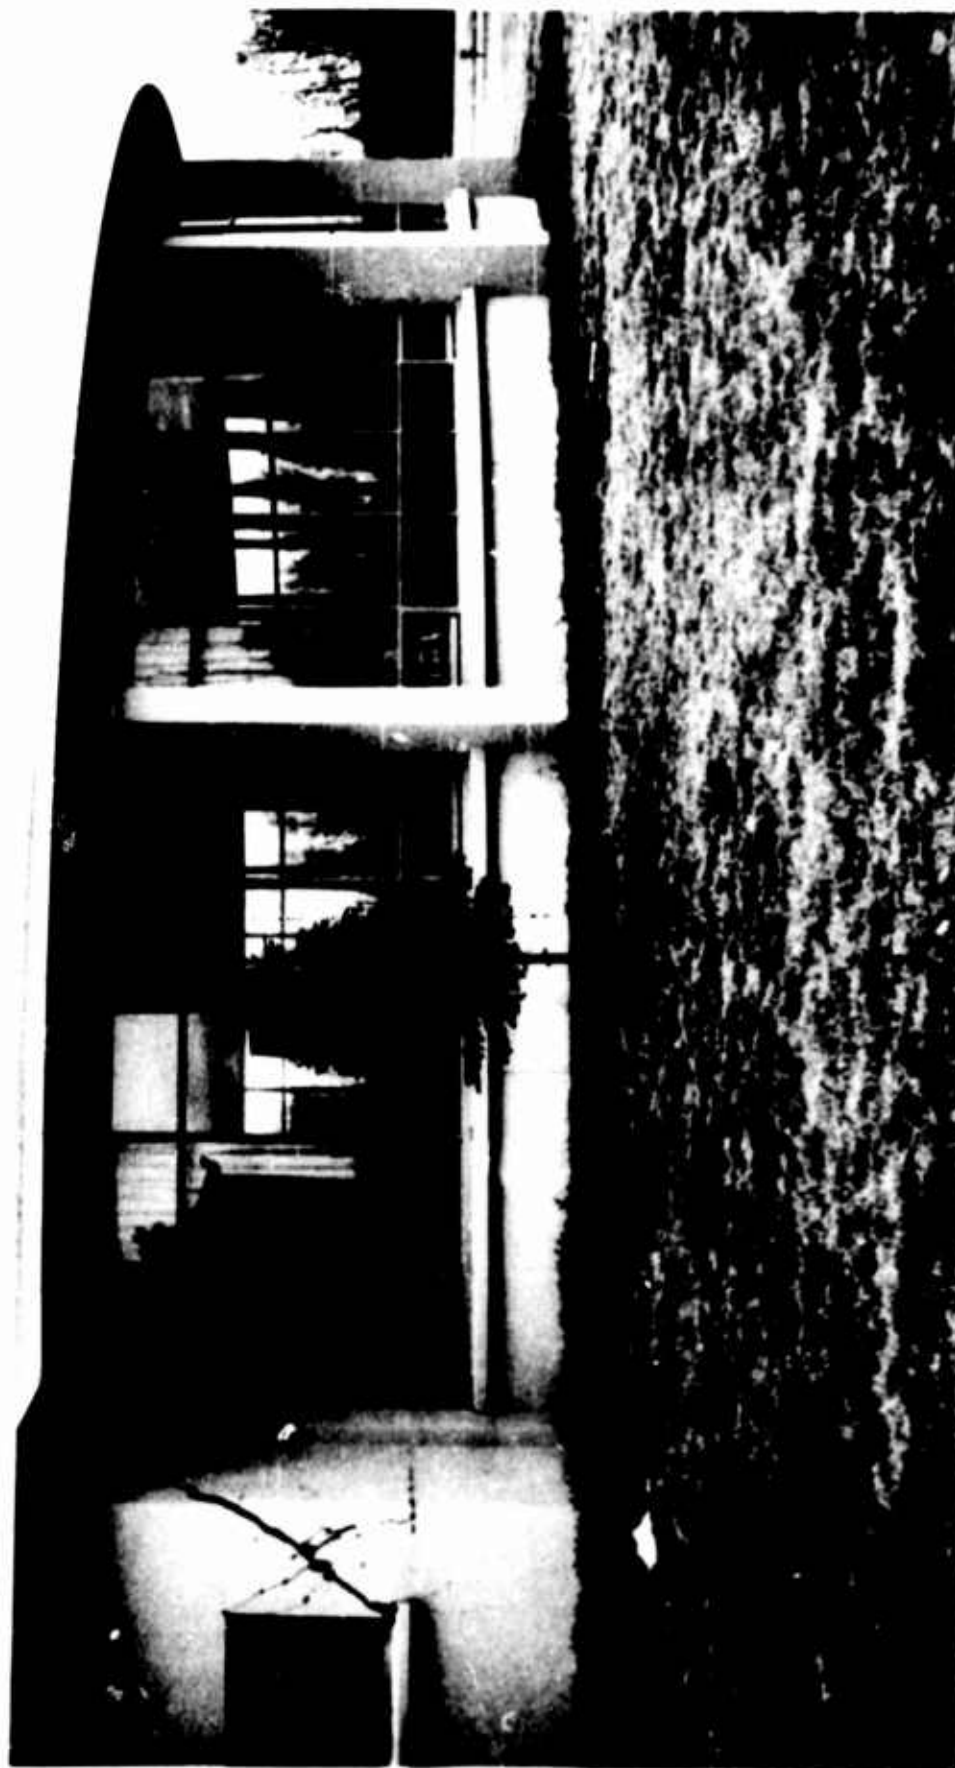
Figure 173. West Anchorage High School (The library received relatively minor damage.)

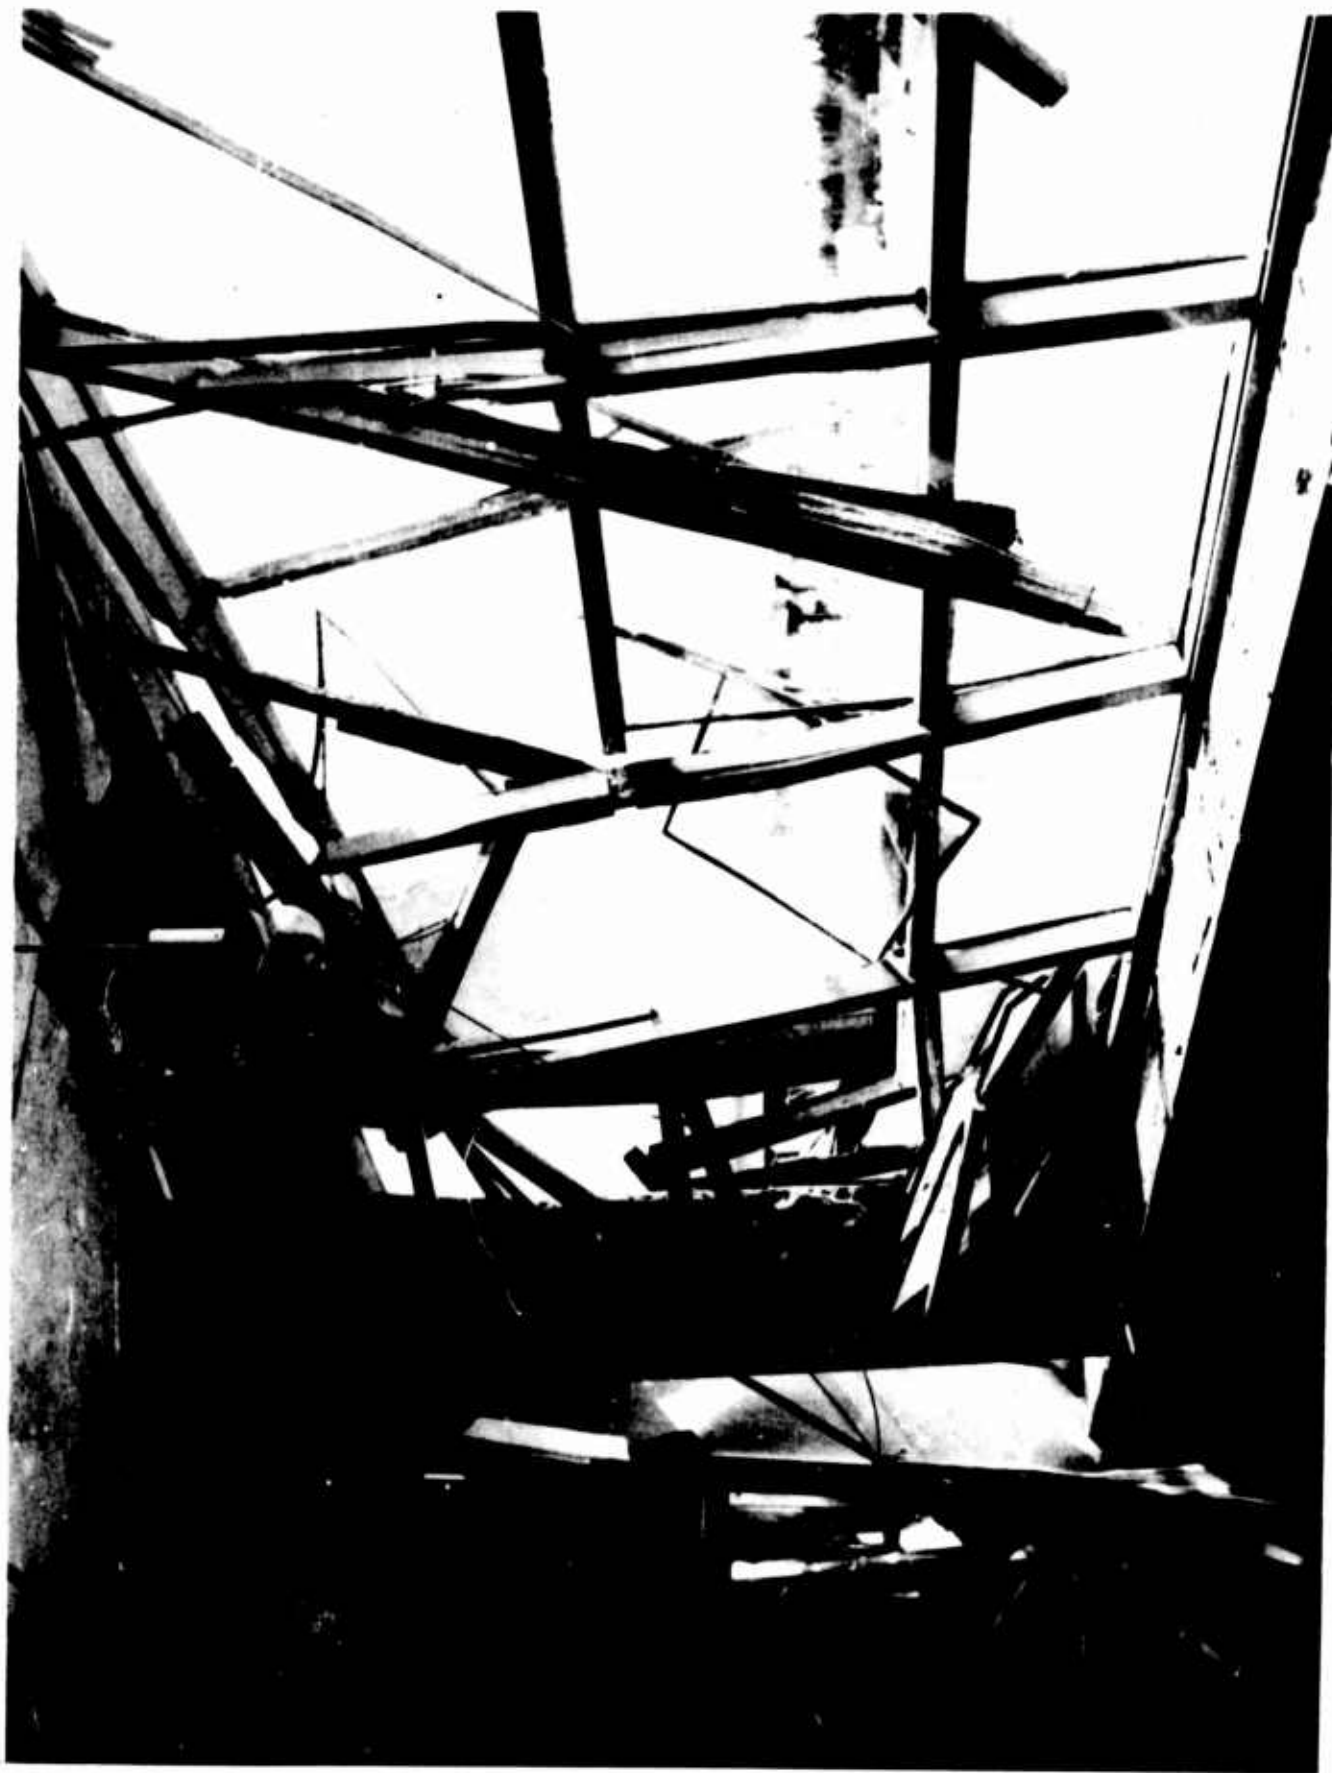
Figure 184. West Anchorage High School (Interior damage to second-floor classroom on south side of wing B)

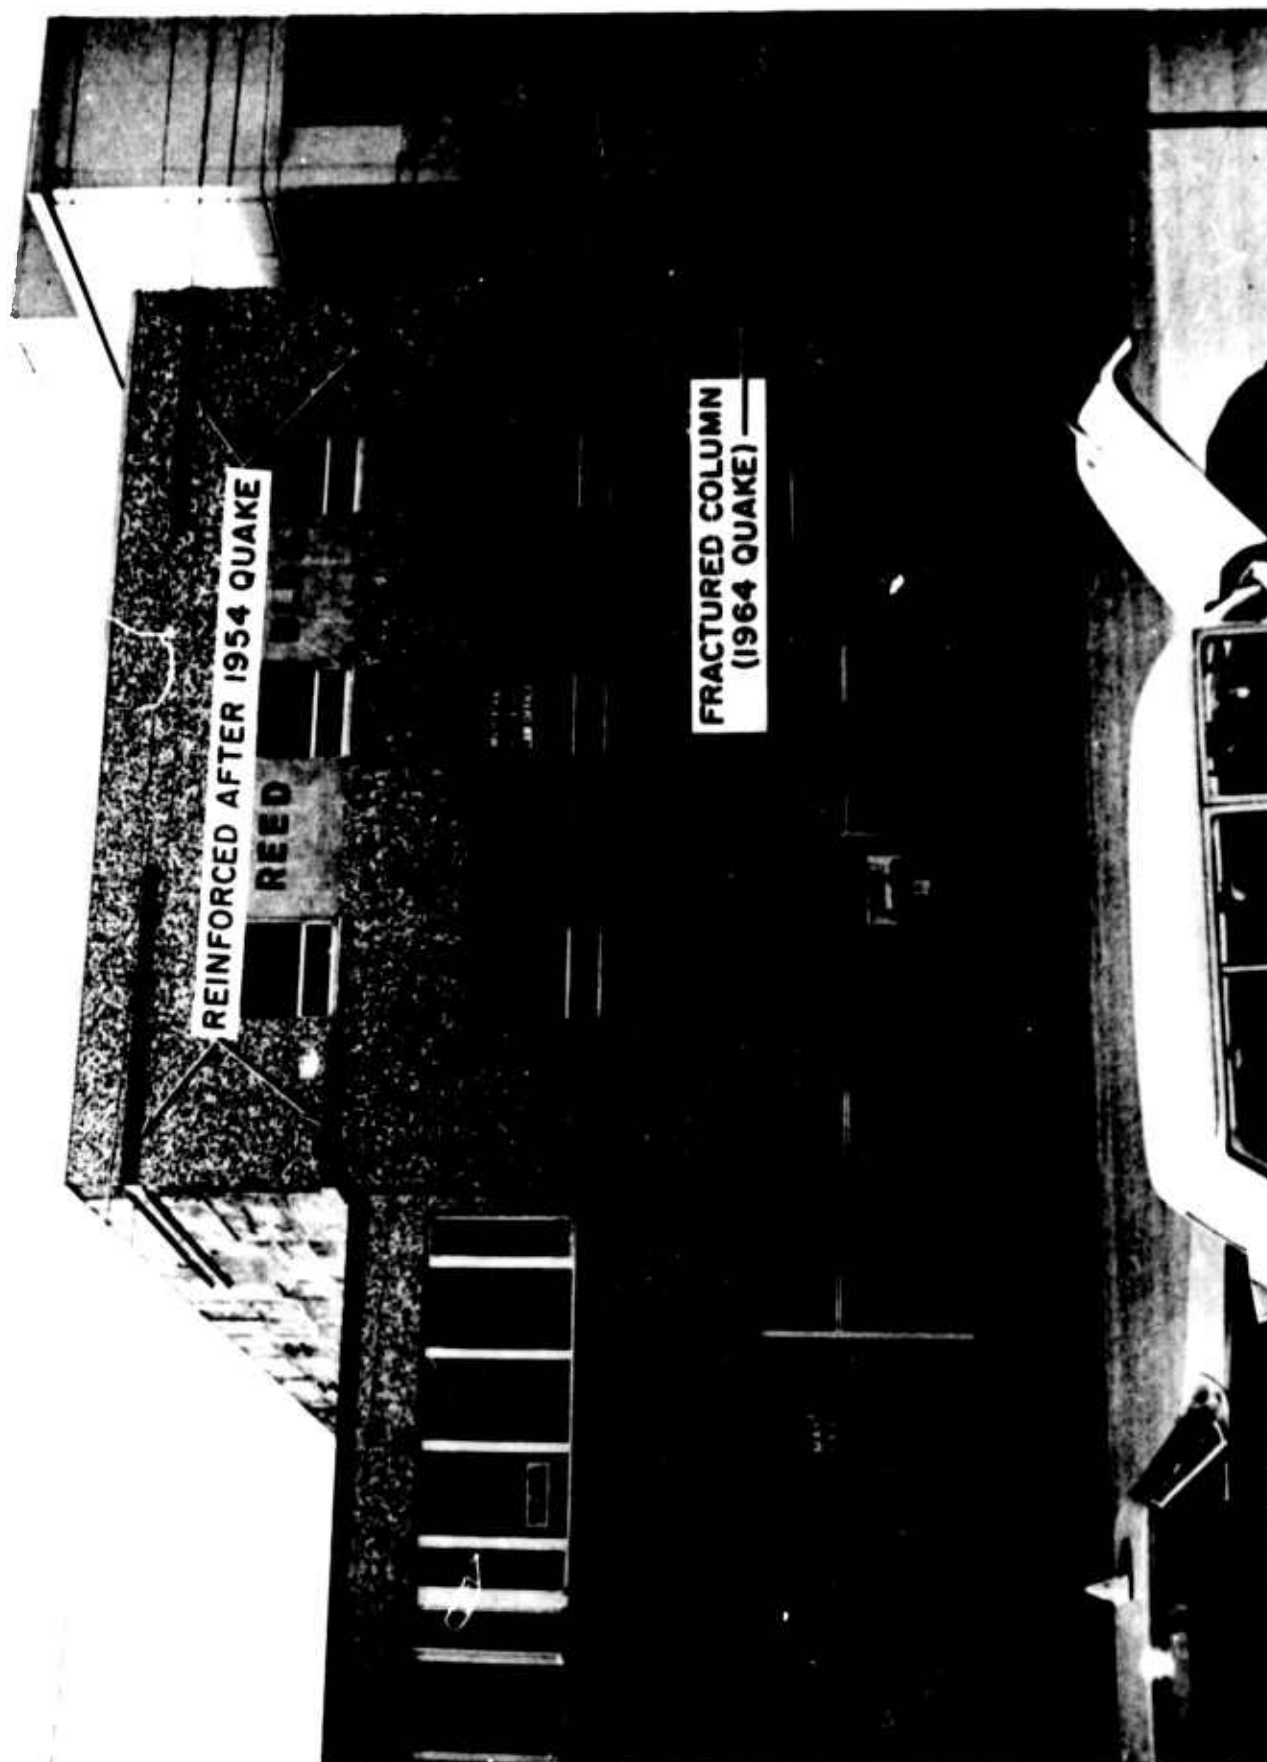
Figure 185. Reed Building (North side of the structure showing effects of previous earthquake damage as well as remedial measures taken to repair recent damage)
